Manhole Inspection Summary

Manhole # S39GG1068MH

Record Plat: **39GG1** Node: **068** Status: **New Manhole (Not in GIS)** Insp Date: **11/12/08 12:00 AM**

Location Address: **805 ARGONNE DR**

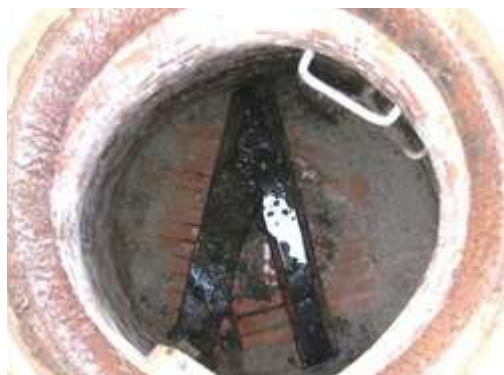
Top View

☐ Parged ☒ **Debris** (not Condition related)

☒ **Evidence Of Surcharge** Depth: **1.5** (ft.) ☐ Active Surcharge Present

Evidence of surcharge - Bench debris.

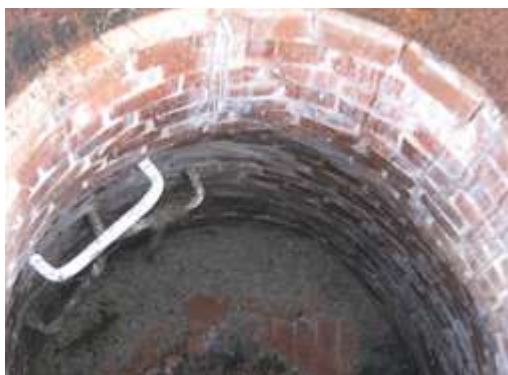
Defect

Condition: ☐ Sound ☐ Cracked ☐ Root Intrusion ☐ Loose Brick ☒ **Deteriorated**

Infiltration: ☐ None ☒ **Joint** ☐ Cracks ☒ **Mortar** ☐ Roots ☐ Wall

Infiltration: ☐ None ☐ Joint ☐ Cracks ☒ **Mortar** ☐ Roots ☒ **Wall**

Adjustment deterioration and infiltration.
Barrel infiltration - other side.

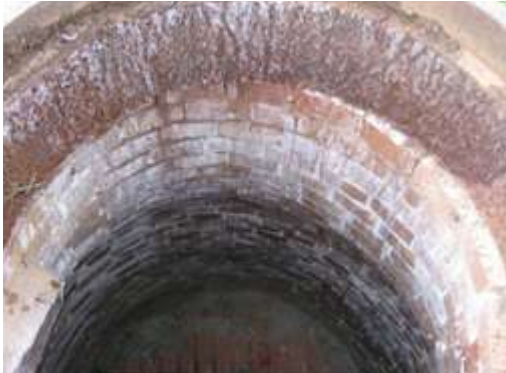
Defect

Adjustment deterioration and infiltration.
Barrel infiltration.

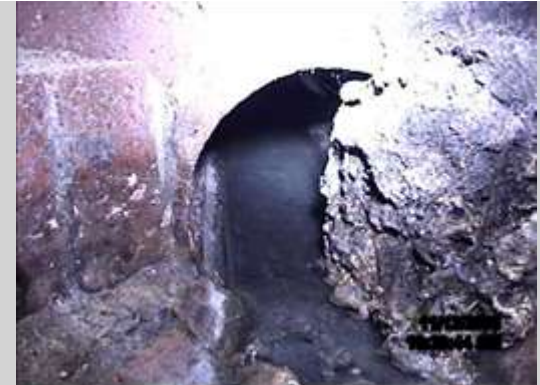
6 in. Circular Gravity Sewer Pipe Out @ 12 O'Clock

Deposits: ☐ None ☒ **Mud** ☐ Sludge ☐ **Debris** ☒ **Grease**

Silt Depth: **0** (in.) Deposits Extent: **Heavy**

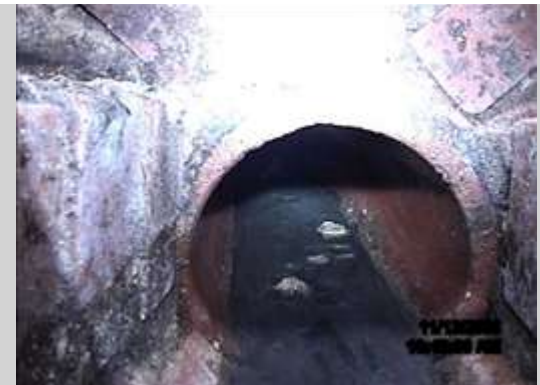
6 in. Circular Gravity Sewer Pipe In @ 6 O'Clock

Deposits: ☐ None ☒ **Mud** ☐ Sludge ☒ **Debris** ☐ Grease

Silt Depth: **0** (in.) Deposits Extent: **Light**

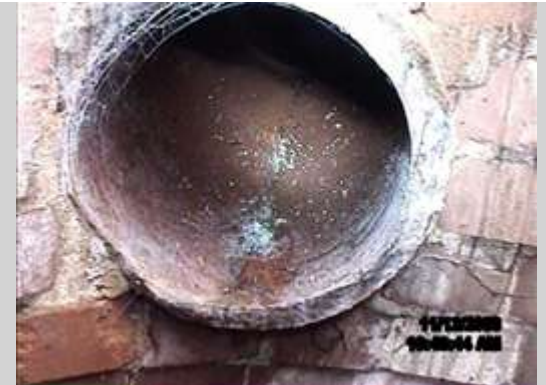
Pipe In @ 7 O'Clock

Deposits: ☐ None ☒ **Mud** ☐ Sludge ☒ **Debris** ☐ Grease

Silt Depth: **3** (in.) Deposits Extent: **Medium**

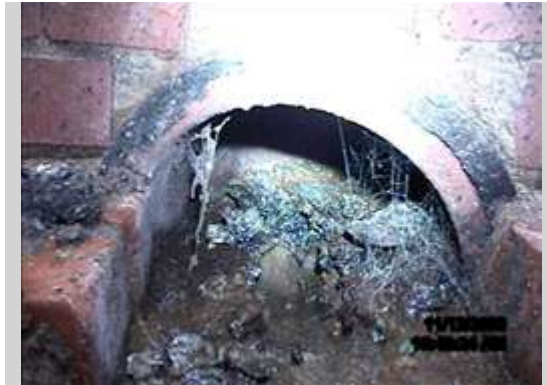
Drop In @ 7 O'Clock

Drop: **Outside** Rod and Bar

Drop Condition: **Open**
